RESEARCH PAPER

**Rummage for a Sustainable Earthquake Resistant Structure
“Construction Techniques and Technologies” in Northern Areas of
Pakistan**

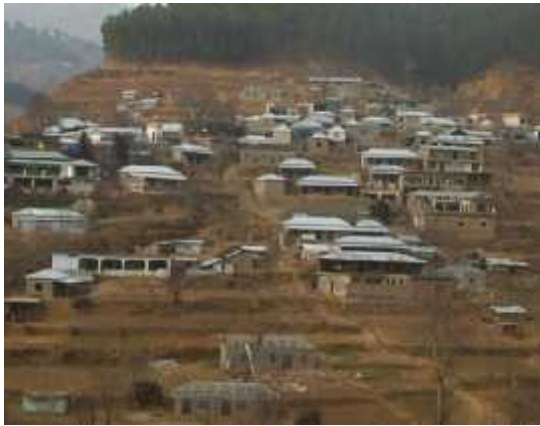
Figure-1: Village in Siren Valley after Disaster

Northern areas Khyber Pakhtoon Khwa Pakistan possess a very strong architectural heritage adorned with both rich design patterns and effective building techniques. But, insane ethicist rehabilitative interventions resulting as aftermaths of a series of natural calamities frequently occurring after October 2005, have practically swallowed several rings from the evolving chain of the built environment. A wide range of indigenous construction materials is gradually being replaced with monotonous concrete blocks, context responsive organic building forms are substituted with typical cubic modules and climate-responsive roofing and fenestration systems are being dominated with standardized metal objects (Figure 1& 2).

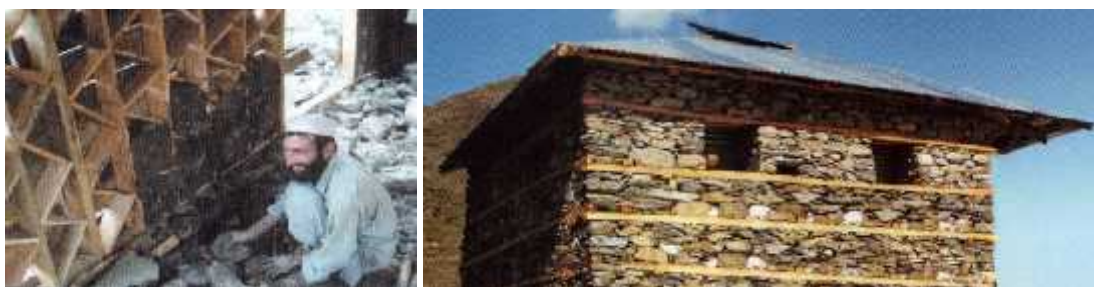
Figure 4:(Left) Construction process of *KotDhijji* method using wooden diagonal bracings. (Right) *BahitterTarz-e-Tameer* with horizontal wooden elements

Most of the people adopted the proposed design and technique of ERRA because it was a free-of-cost house yet not appropriate enough to protect people from the cold environment of the Valley. Some introduced effective insulating techniques of these structures but it was expensive. A traditional method of the Siren Valley was Dajjhii entirely ignored by the ERRA presenting a program to present permanent rehabilitation program for the affected communities. A typical two-room with a front veranda was the core design which could not cover the needs of the family structure and social values of the locality. Traditionally, two construction techniques were being used in the area, which had proved to be earthquake resistant. One was the *KotDhijji* method, and the other was *BahitterTarz-e-Tameer*(Figure 4).

This method was already in practice in the affected areas. This was a historically evolved construction method that was more stable and earthquake resistant. The method was based on the use of diagonal braces which added to the strength of the structure and also divided the walls into relatively smaller sections. In case of sudden collapse, such structures caused minimum damage to the lives of residents and other livestock (Figure 8).

The most famous and popular among the community was the traditionally evolved through millennia the KotDhajji technique. The technique is based on the concept of diagonal bracings between the courses of masonry. Space between the braces is filled up with rubble stone masonry (Figure 13). The technique is the most preferred and trusted among the community.

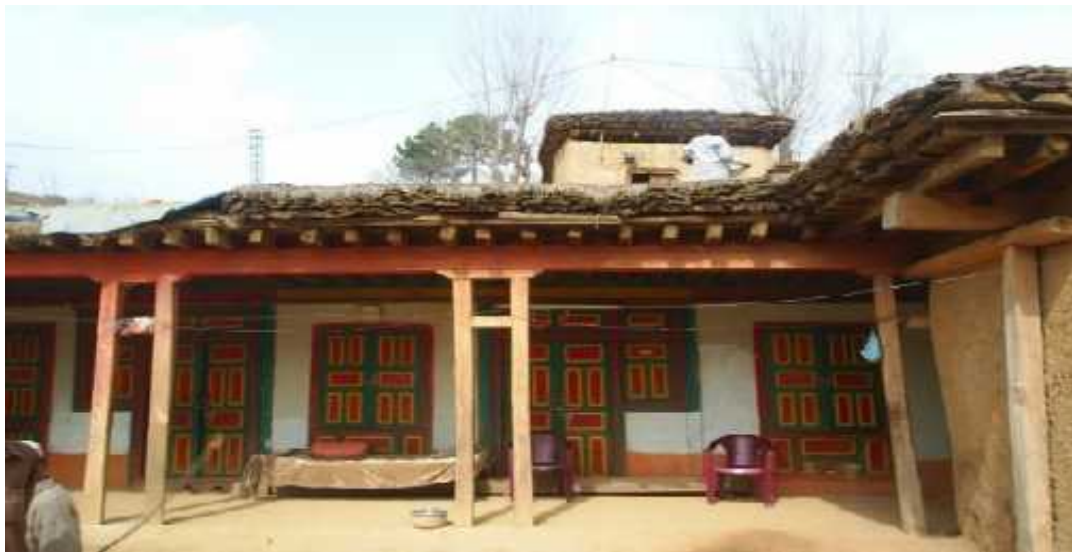
Figure 5:A House in Hair Paina Immediately after 2005 Earthquake

Among the selected villages, only Hair Paina was the least affected community. Almost 90% of the buildings in the village were safe and intact (Figure. 5)

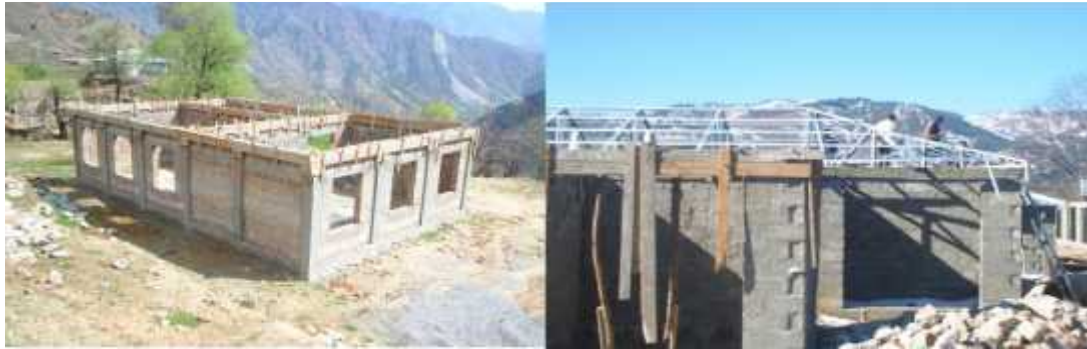
Figure 5 & 6:ERRA-NESPAK Construction Technique Using Brick (Left) and Concrete Blocks (Right) in the area at a large scale and it became popular even in the subsequent self-made constructions.

One of the most important and extremely popular techniques adopted in the affected areas was the ERRA-NESPAK construction technique. The technique was a modified shape of confined masonry usually executed using concrete blocks. RCC columns were used on the corners of the rooms after the rest of the walls had been erected to a certain height. Pouring of concrete after completing masonry to a certain level acted dual purpose: one to provide strength to the overall structure and the other to hold together the masonry and the structure columns (Figure 5 & 6)

There may be several reasons for the popularity of this technique but the most obvious and apprehensible is that the technique was completely sponsored by the ERRA. It was this construction technique that introduced hollow concrete blocks

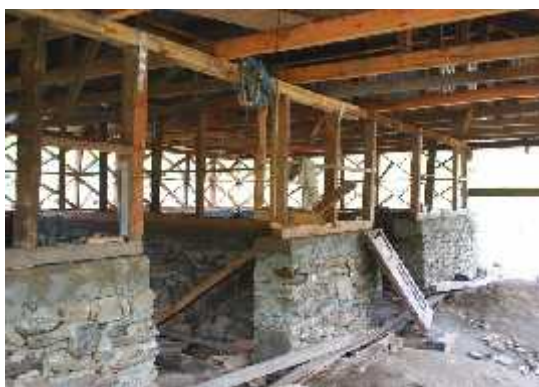
Figure 7:Under Construction Building Showing Technique

Karavan Ghar was based on the locally used technique Bahitter which was already being practiced in many villages of the Siren Valley. Wood, stone, lime, and 5% cement was used as the basic construction and binding materials in the construction. The technique was at the second level in the rank of popularity among the community (Figure 7).

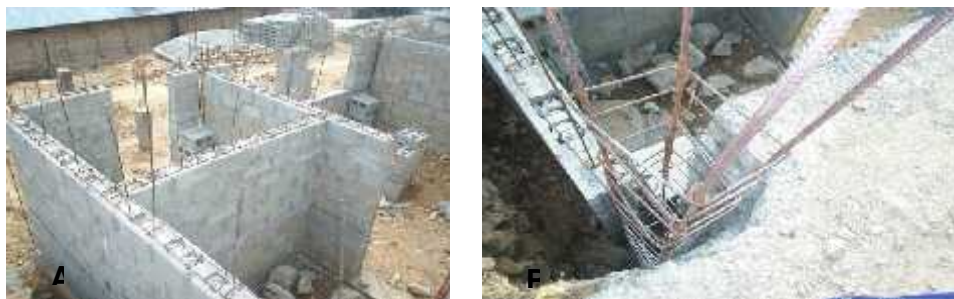
Figure 3.1:Details of ERRA-NESPAK Construction Method

After the earthquake, ERRA and NESPAK jointly developed an earthquake-resistant construction technique, and a whole village of “Kandi” was reconstructed using this technique (Figure 9). The materials used were steel and concrete. The method derives its concept from the frame structure technique. Hollow concrete blocks are laid in cement sand mortar. RCC columns are used on the corners of the rooms. Vertical steel bars are also used at a regular distance in the walls. Walls so built resemble with shear (Figure 10).

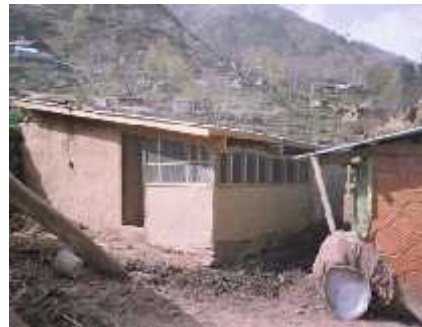
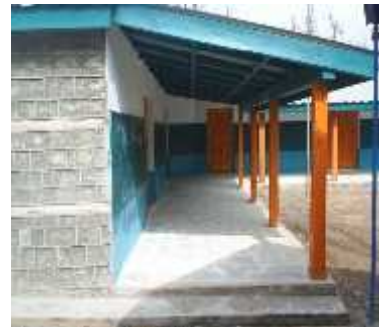
Figure 11 & 12: Karavan Ghar or Stone Masonry

Karavan Program Pakistan presented a model house for the rehabilitation of the affected community. The technique and materials used in the construction were not a new thing for the community (Figure 11 & 12).

The technique was based on the revival of locally evolved stone masonry technique, traditionally laid in mud mortar and also plastered with the mud for aesthetics, weatherproofing, and protecting the masonry joints from wiping away during the rainy season.
